U.S. Environmental Protection Agency Vasquez Boulevard I/70 Superfund Site Replacement Certificate

Daily Quality Control Report **VB/I-70** Lead Based Paint Assessment

LBP Assessment Results

Property ID # 163 / 3329 High Street

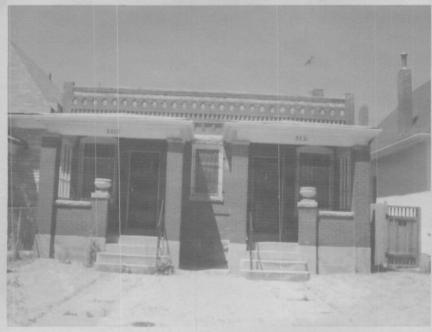
East exposure of property (left porch)

White wood window frame contains peeling lead paint

White wood porch trim / soffit contains cracking lead paint
